**Report Date** 1/1/2008

**Company** Quality Home Inspection  
**Address** 416-723-8913  
**Thermographer** Igor Krylov

**Customer** John Doe  
**Site Address** 5 Main St., Toronto, ON  
**Contact Person** John Doe

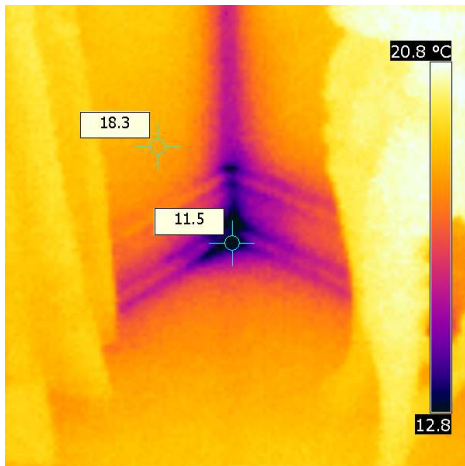
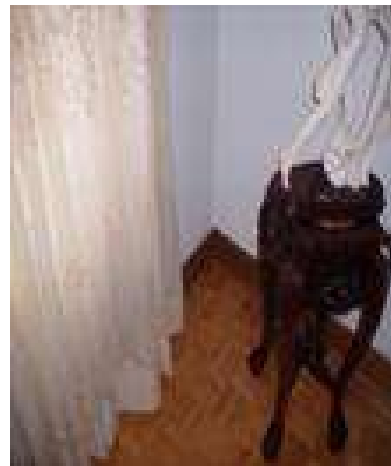
Image and Object Parameters		Text Comments
Camera Model	FLIR B-CAM Western S	
Image Date	2008:02:01 21:47:48	
Image Name	IR_0048.jpg	
Emissivity	0.95	
Reflected Temperature	22.0 °C	
Object Distance	6.6 ft

There is an insulation problem in the corner of the leaving room. There is an air infiltration into the house. Problem: heat lost, moisture build up, growing mold in the future. Problem needs further investigation and correction.

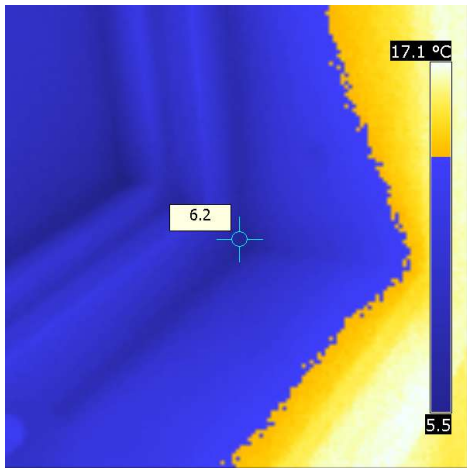
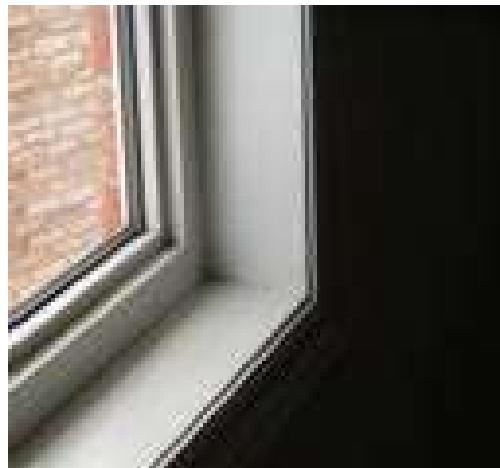
Image and Object Parameters		Text Comments
Camera Model	FLIR B-CAM Western S	
Image Date	2008:02:29 22:09:36	
Image Name	IR_0078.jpg	
Emissivity	0.95	
Reflected Temperature	22.0 °C	
Object Distance	6.6 ft

There is an air draft around the window in the bedroom. Problem: heat lost, moisture build up, overpayment for heating and cooling. Problem needs to be corrected.

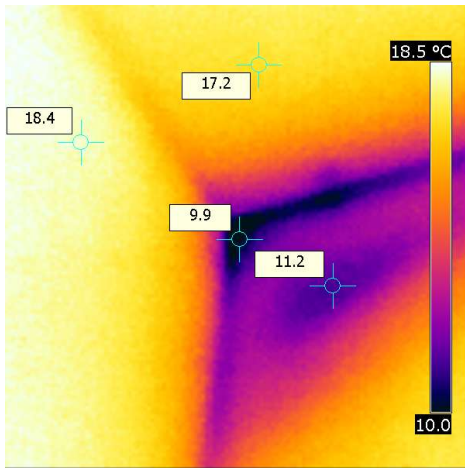
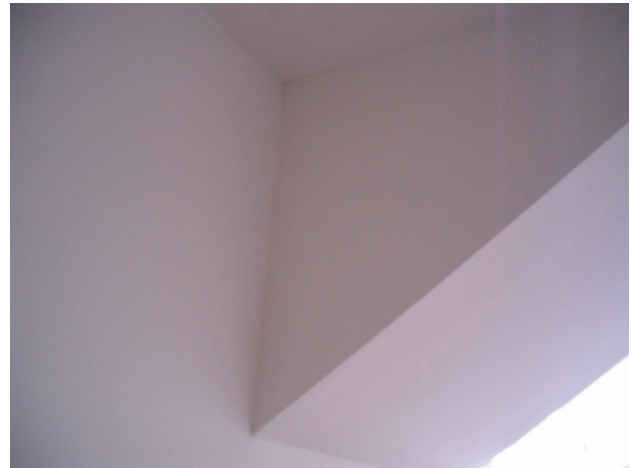
Image and Object Parameters		Text Comments
Camera Model	FLIR B-CAM Western S	
Image Date	2008:02:29 23:05:12	
Image Name	IR_0100.jpg	
Emissivity	0.95	
Reflected Temperature	22.0 °C	
Object Distance	6.6 ft

Description
<p>There is a poor or missing insulation in the arc above bed in the master bedroom. Problem: heat lost, moisture build up, growing mold in the future. Problem needs further investigation and correction.</p>

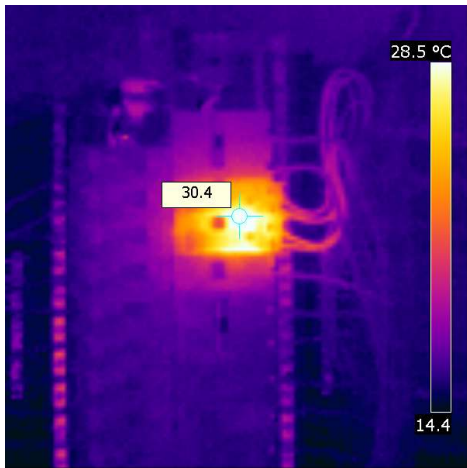
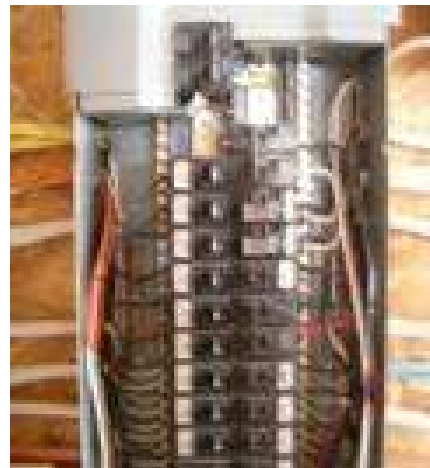
Image and Object Parameters		Text Comments
Camera Model	FLIR B-CAM Western S	
Image Date	2008:02:29 23:20:47	
Image Name	IR_0103.jpg	
Emissivity	0.95	
Reflected Temperature	22.0 °C	
Object Distance	6.6 ft

There is an electrical problem. Overheat breaker. Problem needs to be checked and fixed by professional electrician.
